All Pro Home Inspections

Property Inspection Report

134 Main Street, Yourtown, IL 62XXX
Inspection prepared for: John Doe & Jane Doe
Real Estate Agent: Support - Home Inspector Pro

Date of Inspection: 2/12/2013 Time: 9:15 am
Age of Home: 8 years Size: 1810 sq ft.

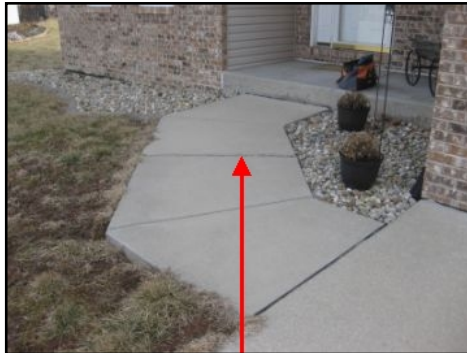
Materials: Concrete
 Observations:
 • Some areas have settled creating trip hazards, recommend repair.

Trip hazards in walkway, exercise caution.

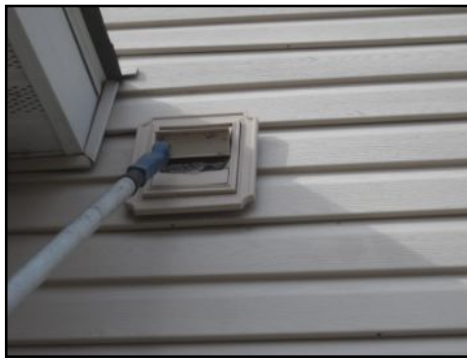
- Exterior dryer vent flapper needs the lint cleaned out of it.

Exterior dryer vent needs cleaned out.

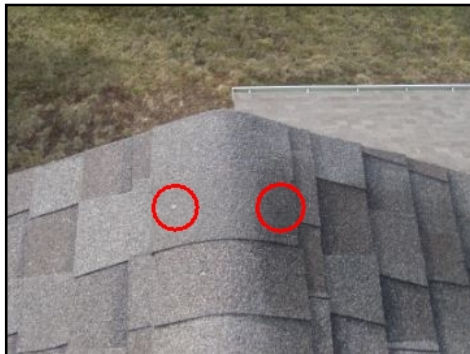
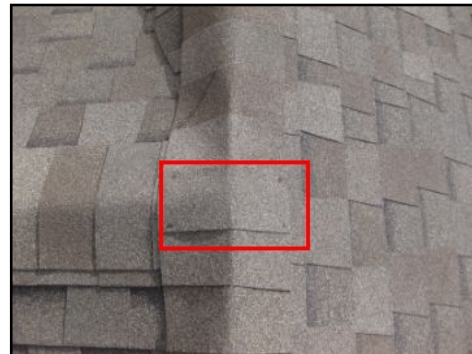
• There were several roofing nail heads exposed, these need to be sealed to prevent rusting.

Exposed nail holes should be sealed.

Typically the last shingle on the ridge cap has to have the nails uncovered due to location. It is recommended to seal the heads of these nails with some good quality caulk or sealant.

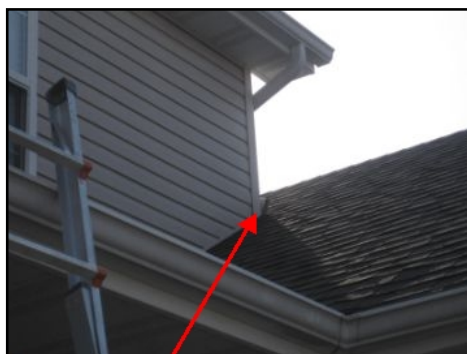
• Recommend installing down spout extension from the second floor gutter to the lower gutter or ground to prevent water from discharging on shingles.

Recommend extending 2nd floor gutter downspout down to lower gutter.

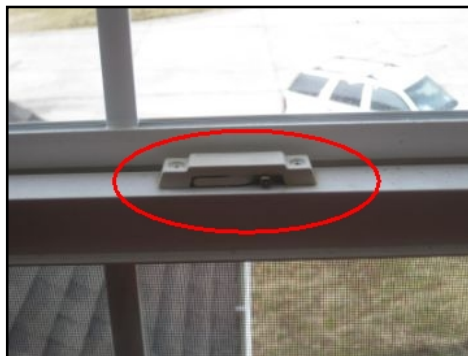
- Master bathroom window latches are broken, and will not easily lock, recommend repair.

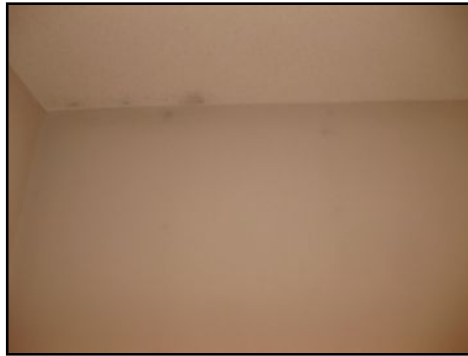
- There is a substance on the ceiling that resembles mold. Qualified personnel can only positively identify mold through sampling and analysis. The General Home inspection is not an inspection for mold and the inspector specifically disclaims and assumes no responsibility for identifying the presence of mold fungi. Recommend making sure there is proper ventilation in the bathroom area.

Ceiling areas have some stains.

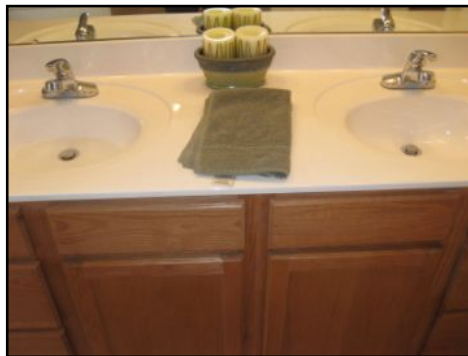
Observations:
 • Left master bathroom sink is very slow to drain, recommend repair.

Left sink drains very slow.

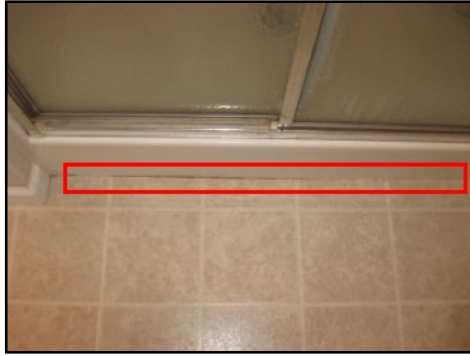
Observations:
 • Recommend caulking where the shower meets the floor.

Recommend caulking.

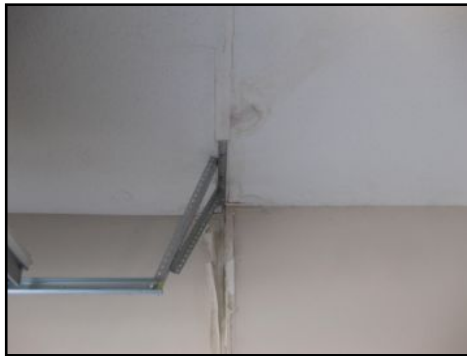
- There were some water stains and minor moisture damage on the north ceiling and wall. This area tested dry with moisture meter at time of inspection.
- There is no access to attic above garage to inspect for leaks. Recommend monitoring this area.

Past water leak and minor damage noted on north ceiling and wall.

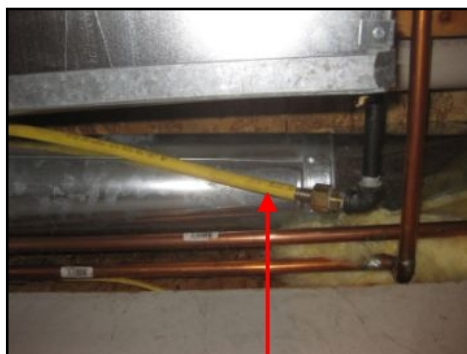
- The CSST flexible gas line needs to be bonded to the electrical grounding system. Recommend repair by a qualified contractor.
- Go to this link to learn about csst gas line: <http://www.csstsafety.com/>

The csst gas line needs to be bonded to a suitable ground.

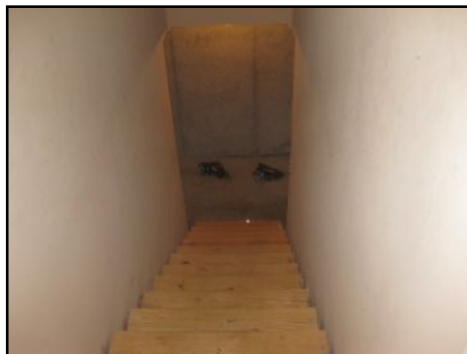
- **SAFETY ISSUE** - Recommend installing hand rail on basement steps.

Recommend installing handrail on basement stairway.

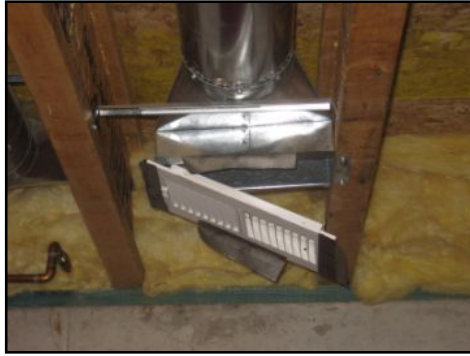
- Metal duct.
- **Heat register in basement if loose, recommend repair.**

Loose register in basement needs secured.
